# DENVER HELICOPTER JOB

# Denver Network Helicopter Job

# The Accident

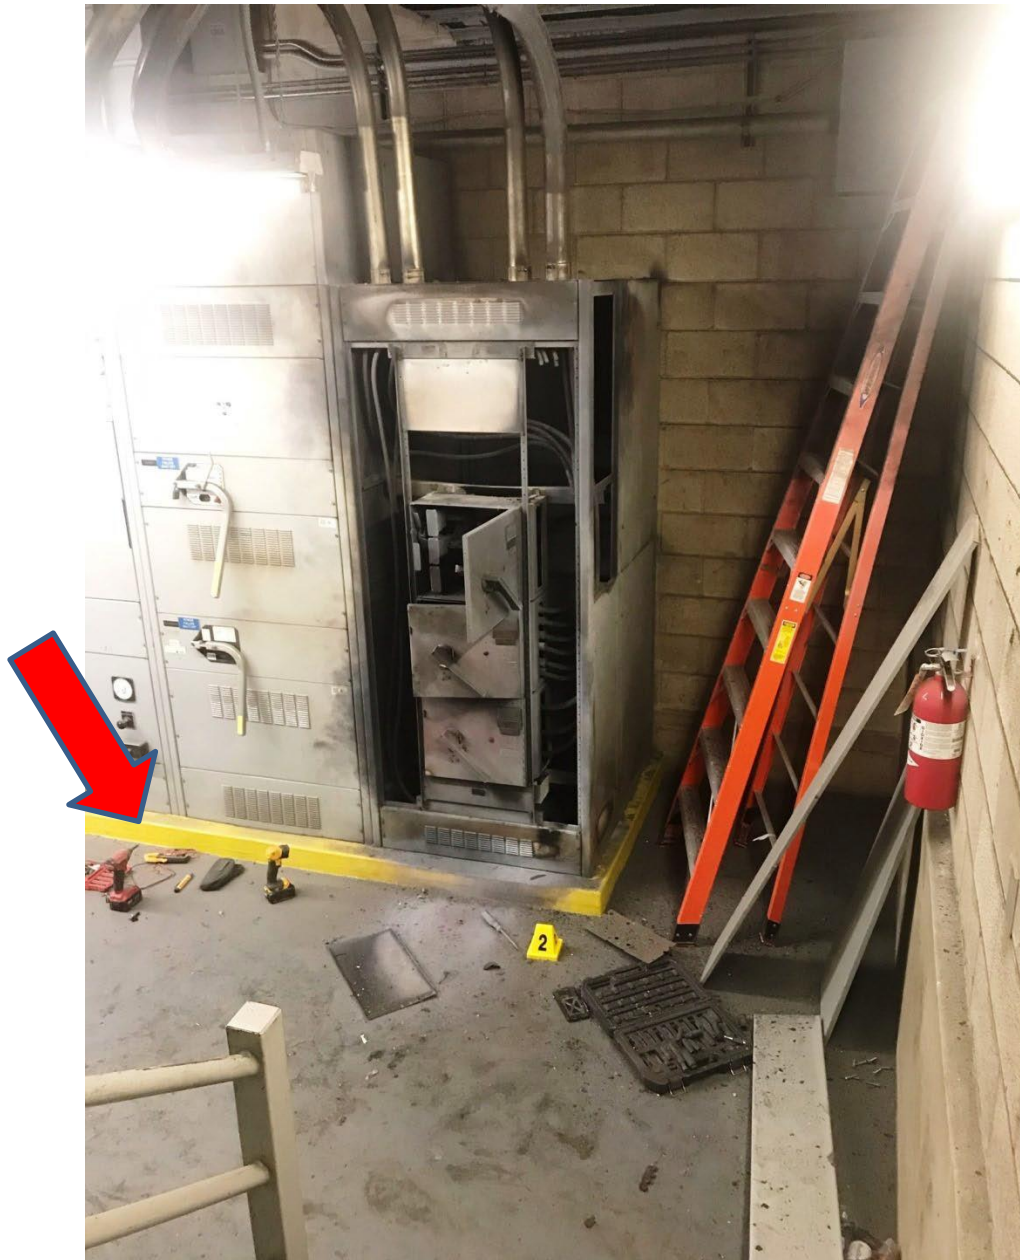
This is a picture of the switchgear. You can see the static pencil on the ground laying right next to a volt meter.

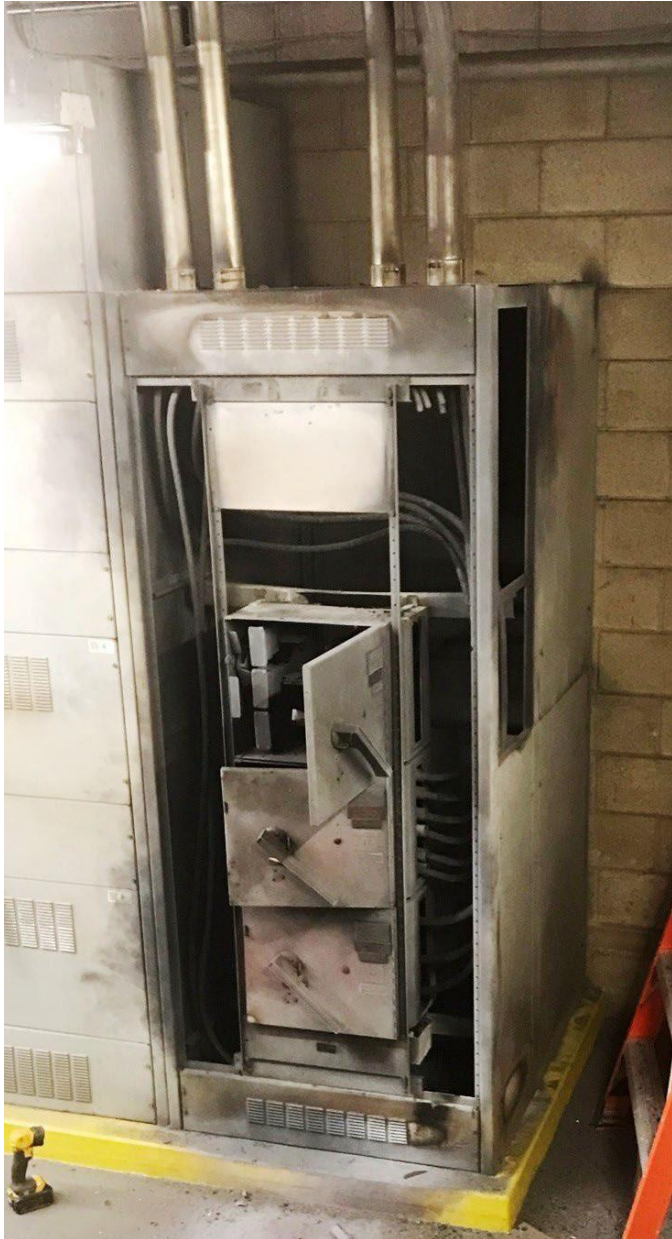
The front of the burnt up switchgear.

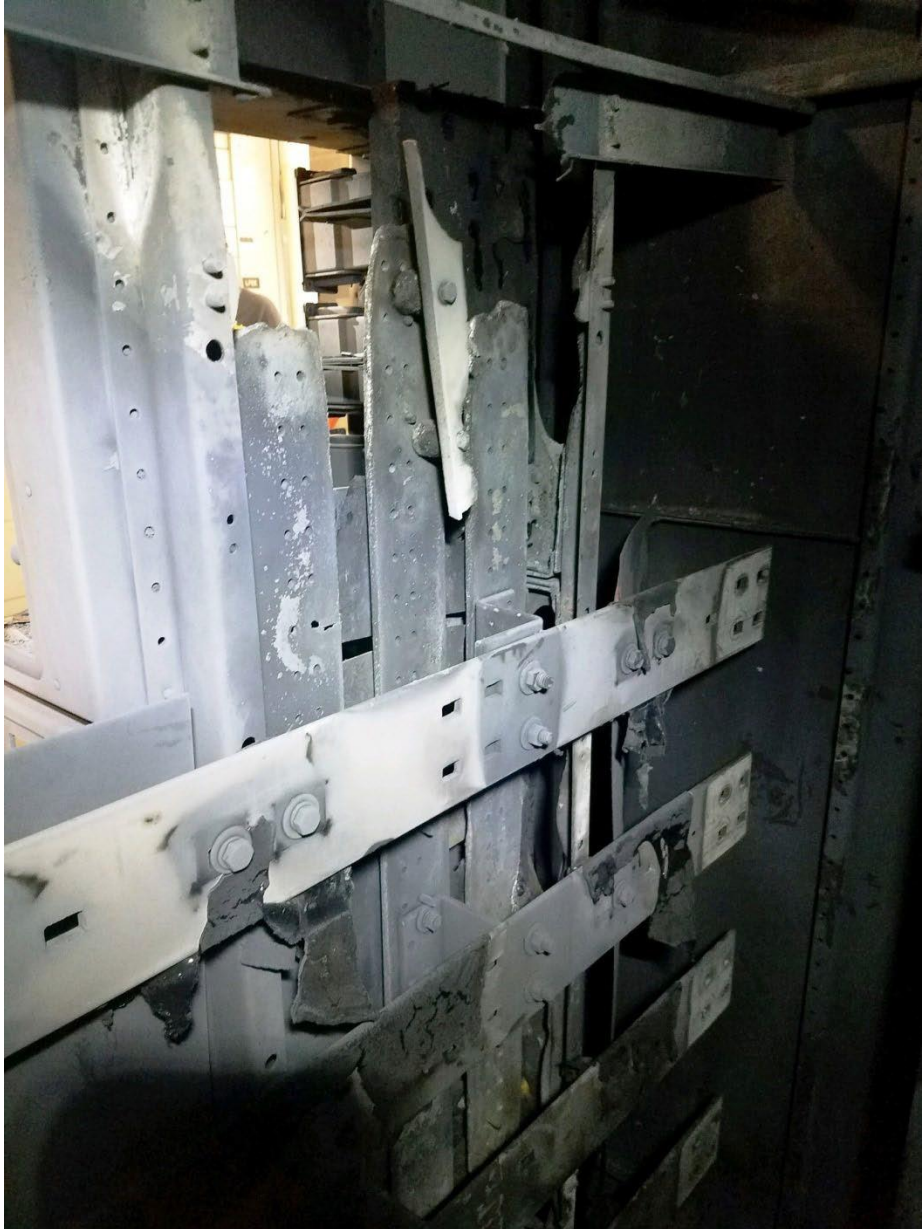
This is a picture of the inside of the burnt up switchgear.

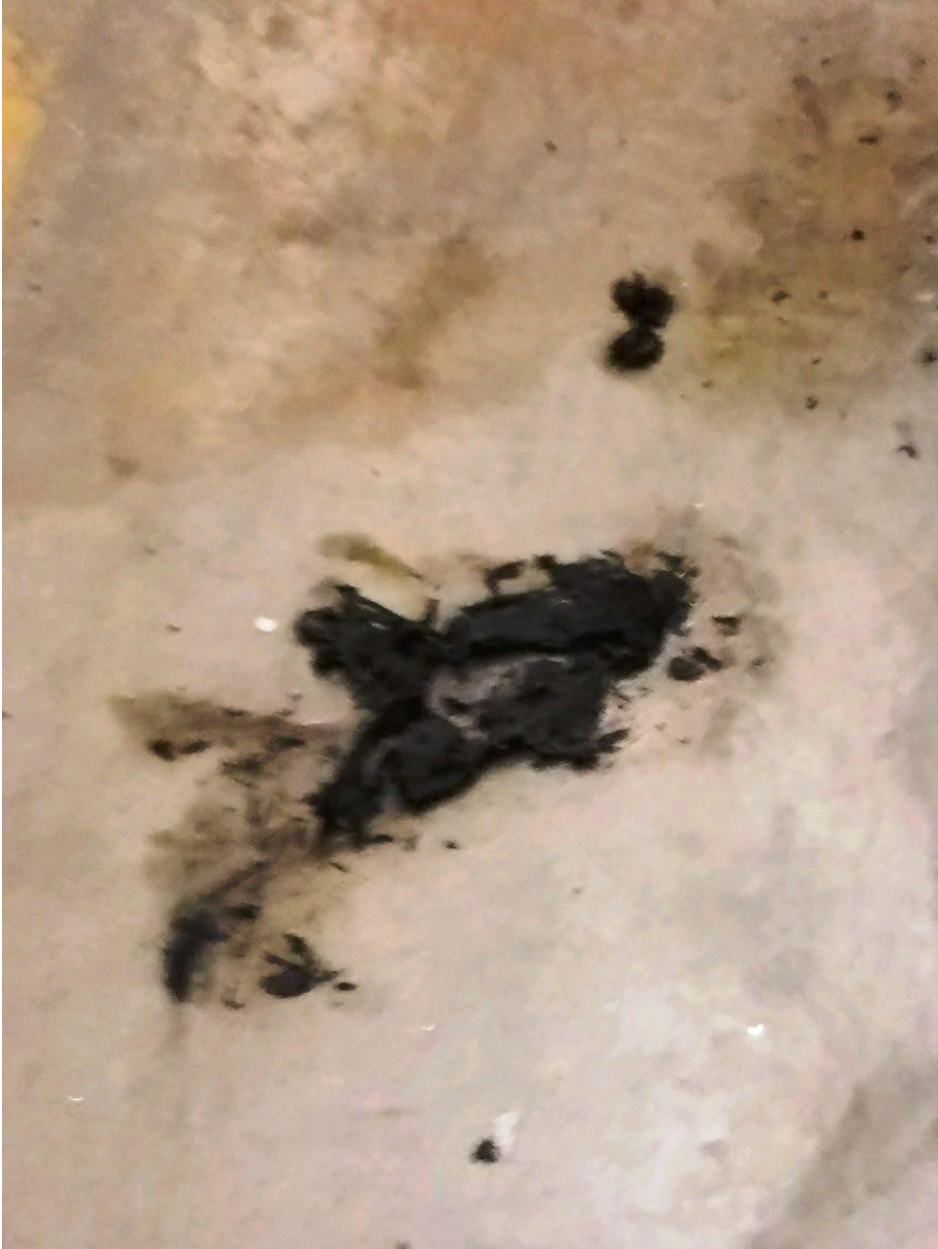
After the initial flash, the apprentice ran from the switchgear room. His shoes were melting to the floor.

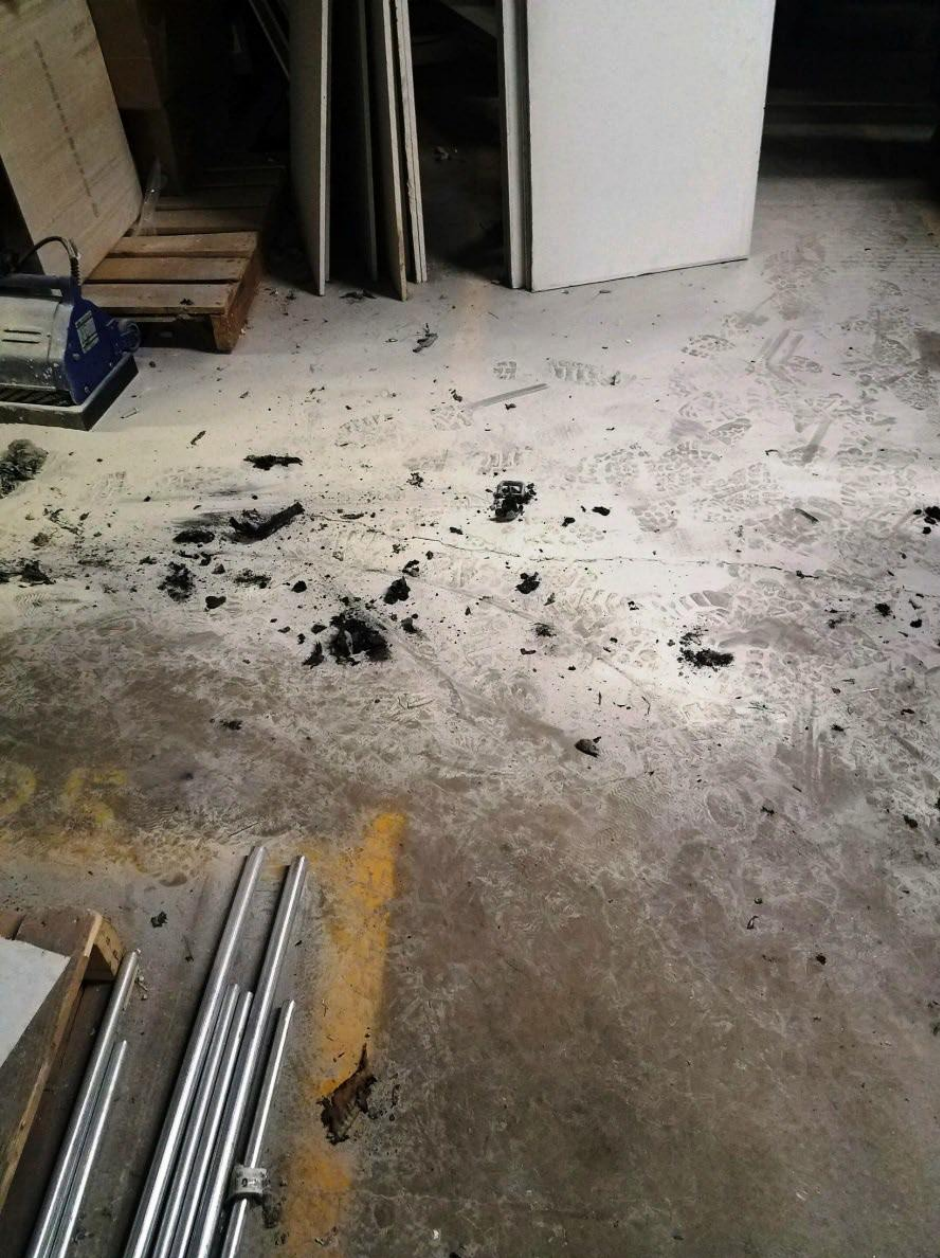
The apprentice fell  
as he turned a  
corner.

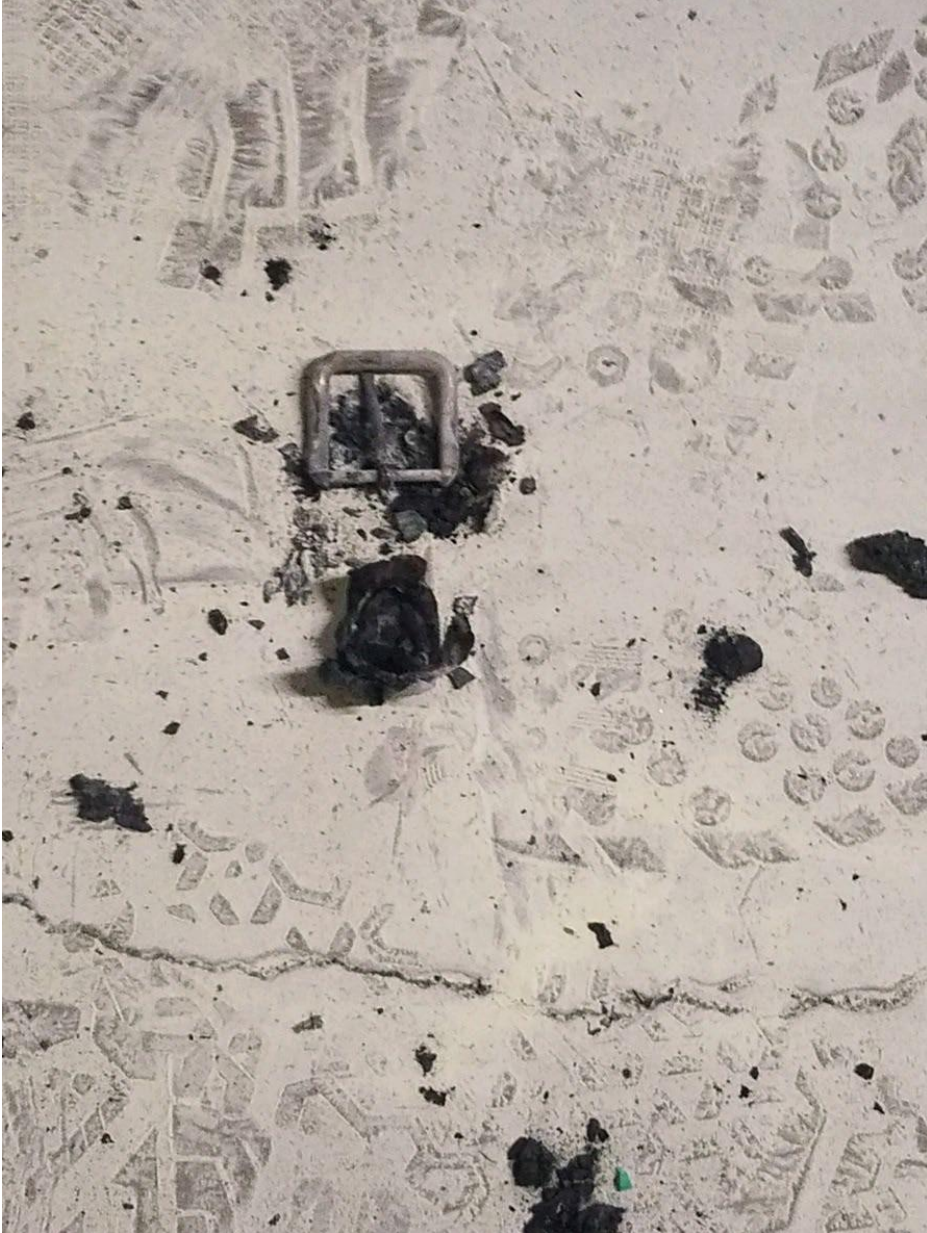
What was left of his belt, the buckle, and jeans, the snap, fell to the ground.

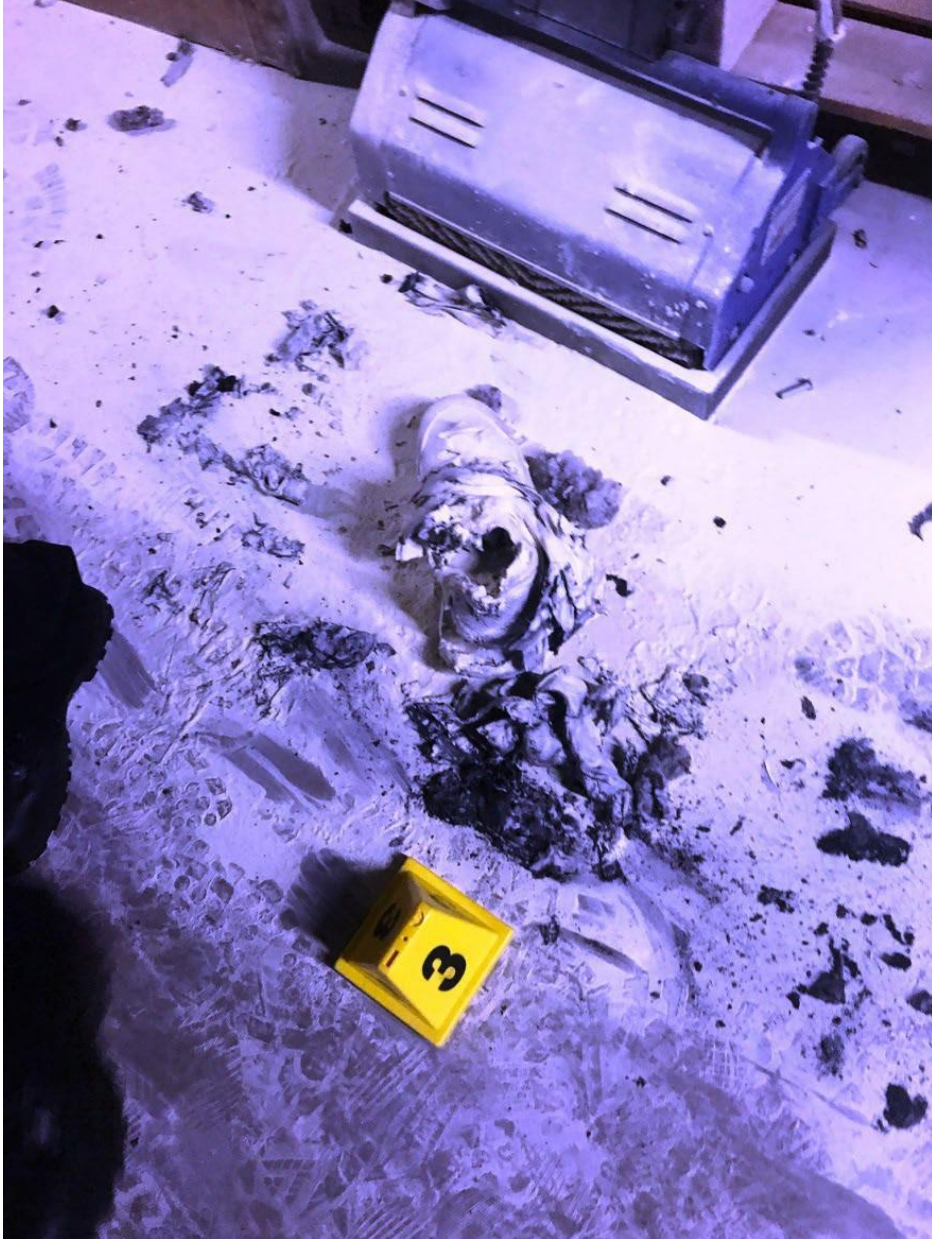
A few more steps  
and the one of the  
melted shoes stuck  
to the ground.

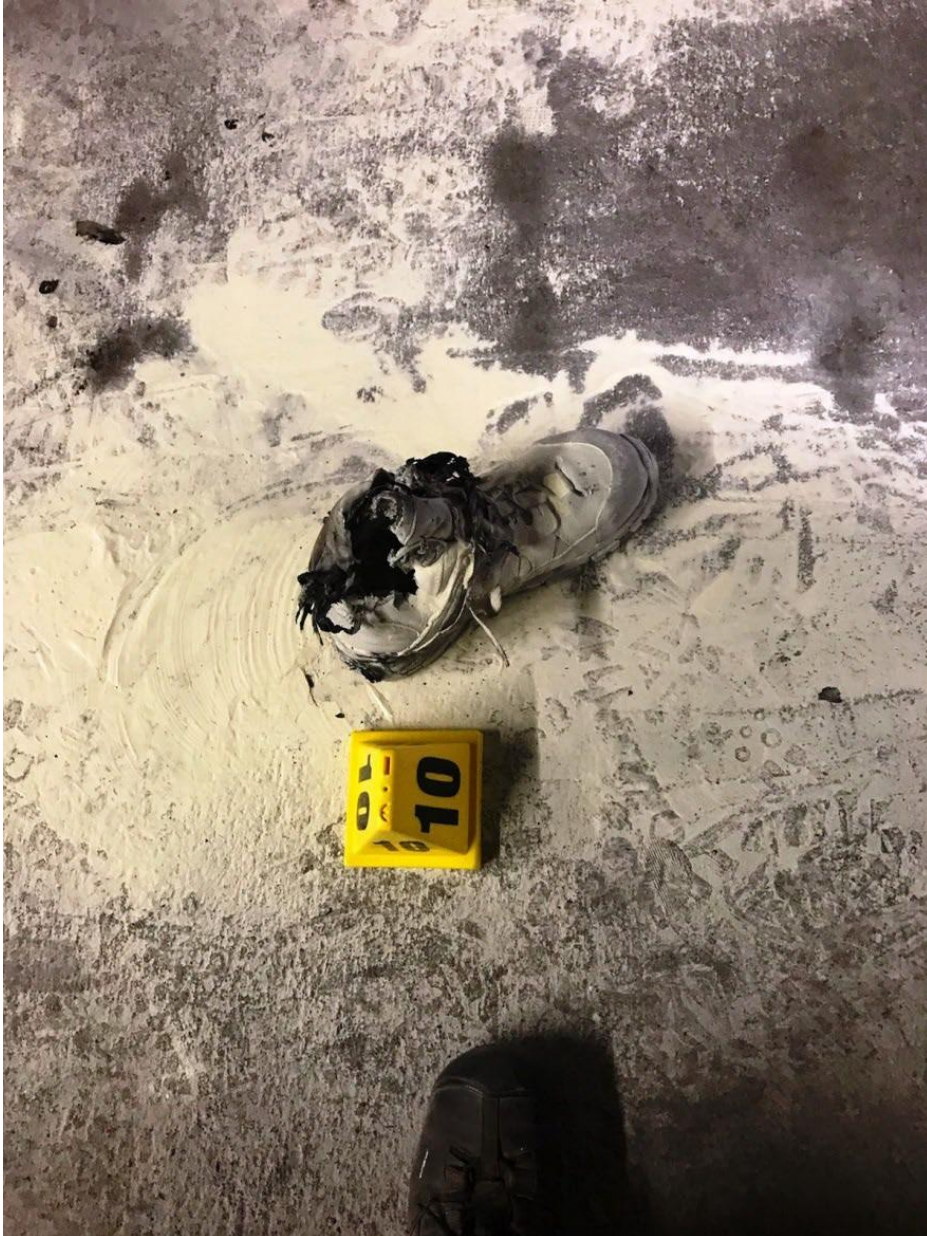
And finally, the second shoe melted to the ground.

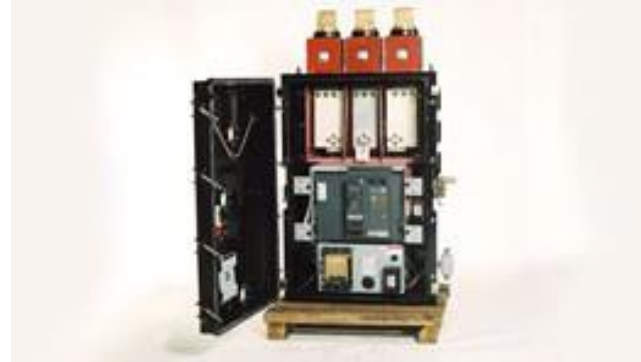
- **Dead front protector.**
- **Higher interrupting and fault close ratings.**
- **Standardized modular components.**
- **No adjustments required and fewer replacement parts.**
- **Built-in wear gauge.**
- **Remote racking ability.** The CM-52 remote racking device provides a means of remotely connecting and disconnecting a network protector from the energized bus-work.
- **CM52 is set up for NPARMS.** Network Protector Arc Reduction Maintenance System (NPARMS) senses fault current in either forward or reverse direction in addition to providing the utmost in arc flash protection. When enabled, the innovative Arc Reduction Maintenance System establishes a preset instantaneous trip level that overrides the time delay function of traditional over current relays and schemes of the associated breaker.
